Appendix D

Charts of Plotted Data from Tensiometers with Performance Evaluation and Recommendations

D1. KEY TO APPENDIX

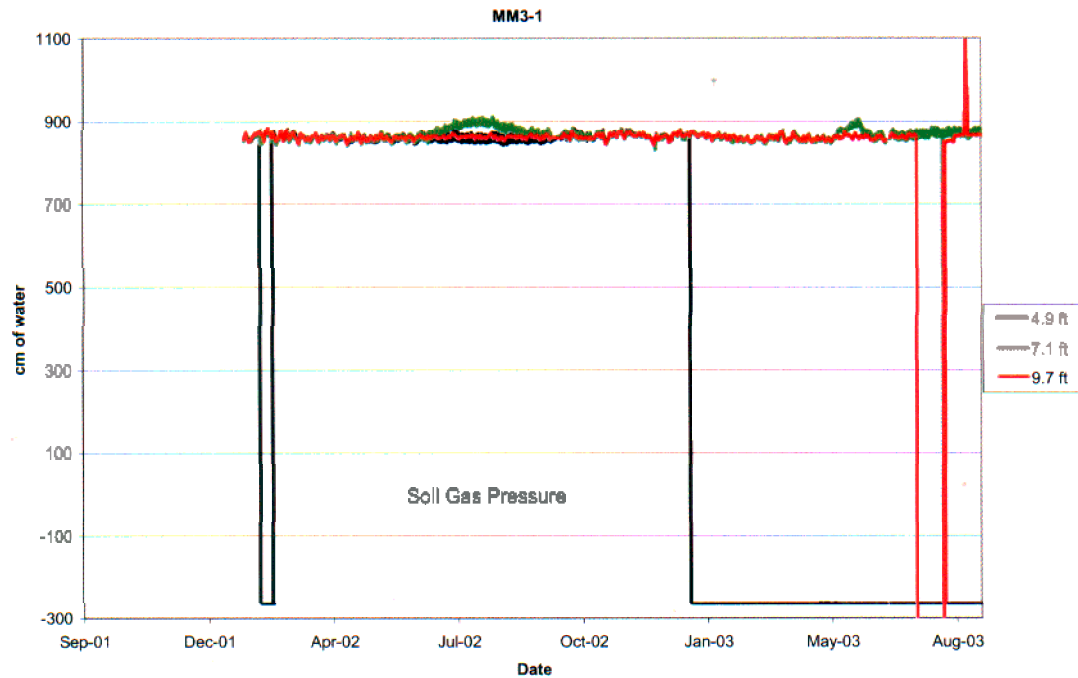
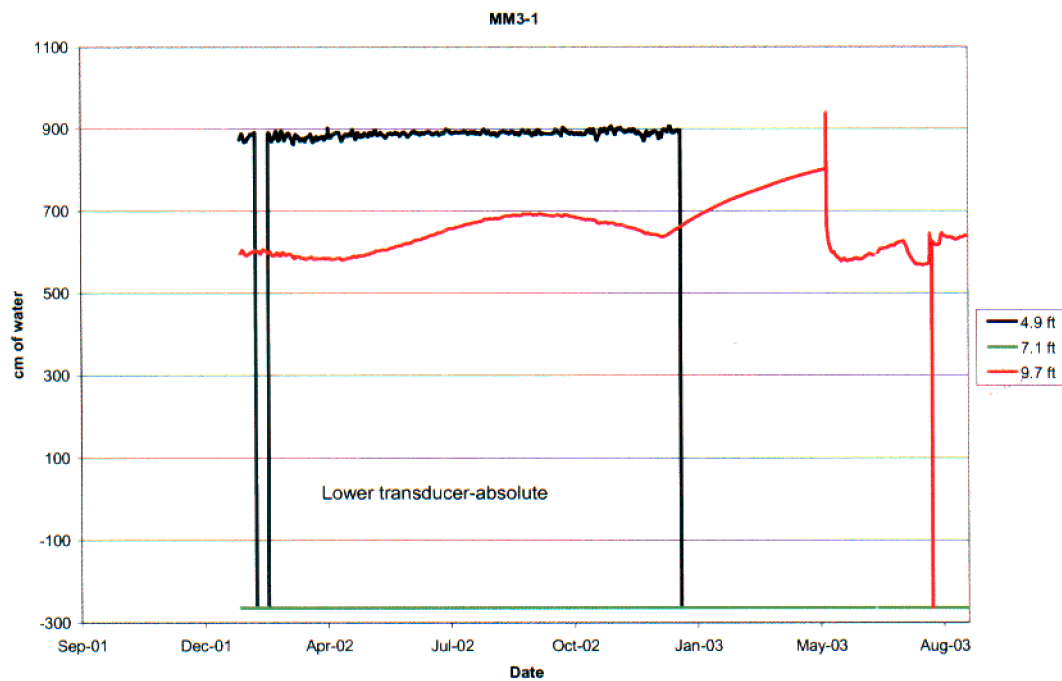
Figure D-16. MM3-1.

T1, 4.9 ft: Soil gas pressure no signal, absolute wp transducer no signal and spool valve not working.
 T2, 7.1 ft: Soil gas pressure working, absolute wp transducer no signal (-273).
 T3, 9.7 ft: Soil gas pressure working, absolute wp transducer working.

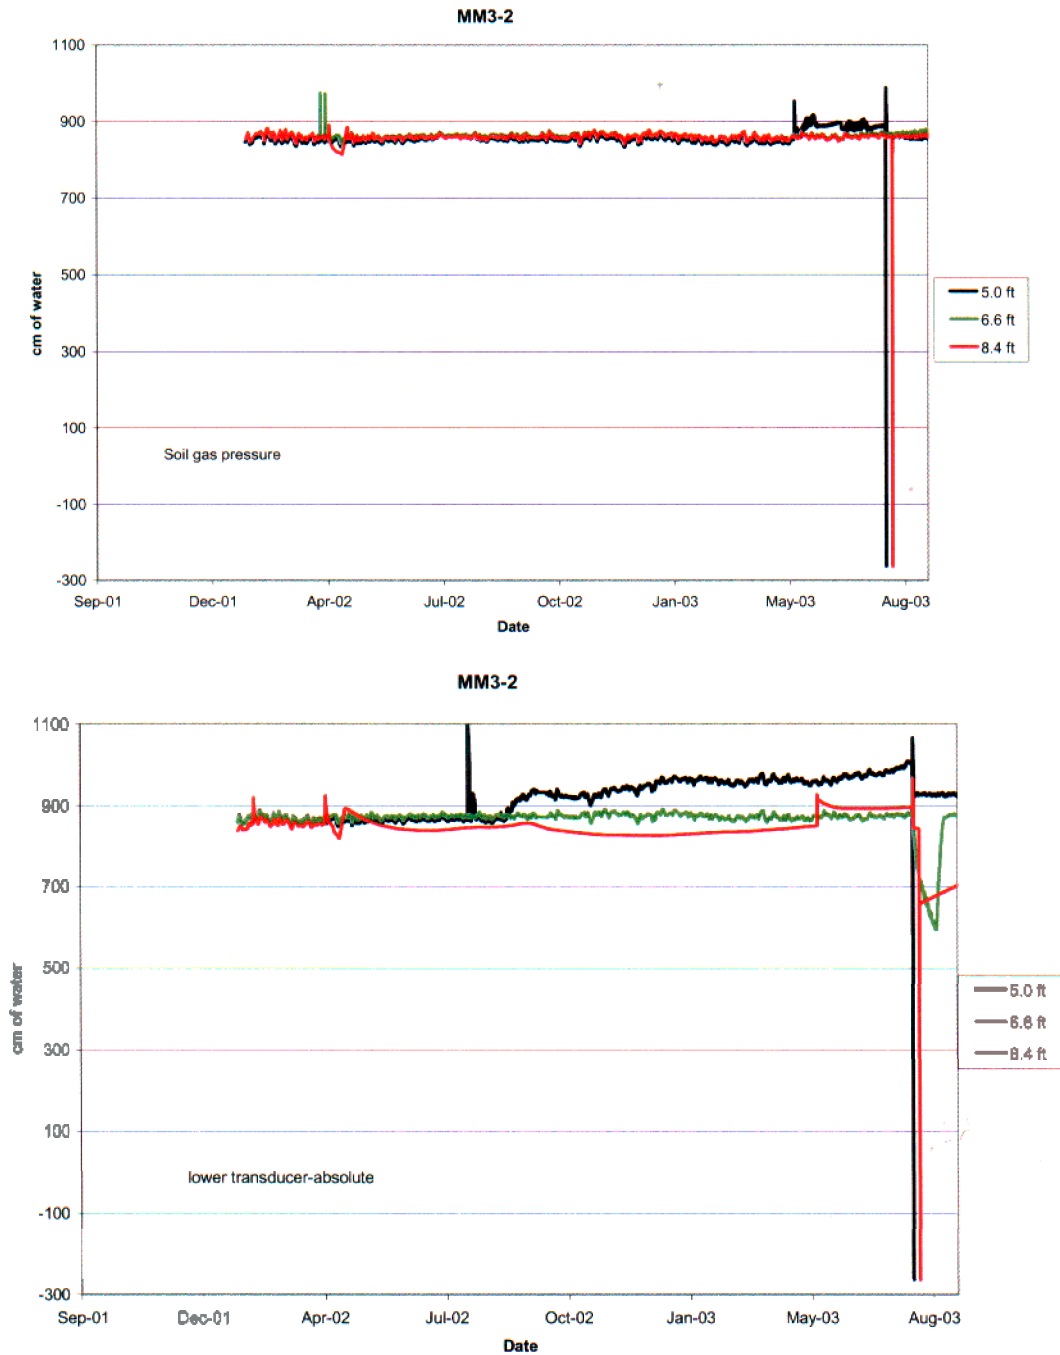
Figure D-17. MM3-2.

T1, 5 ft: Soil gas pressure working, absolute wp transducer shows no sign of holding vacuum.
 T2, 6.6 ft: Soil gas pressure working, absolute wp transducer showed signs of working in fall 2003.
 T3, 8.4 ft: Soil gas pressure working, absolute wp transducer not working, tubing pulled out during field operations.

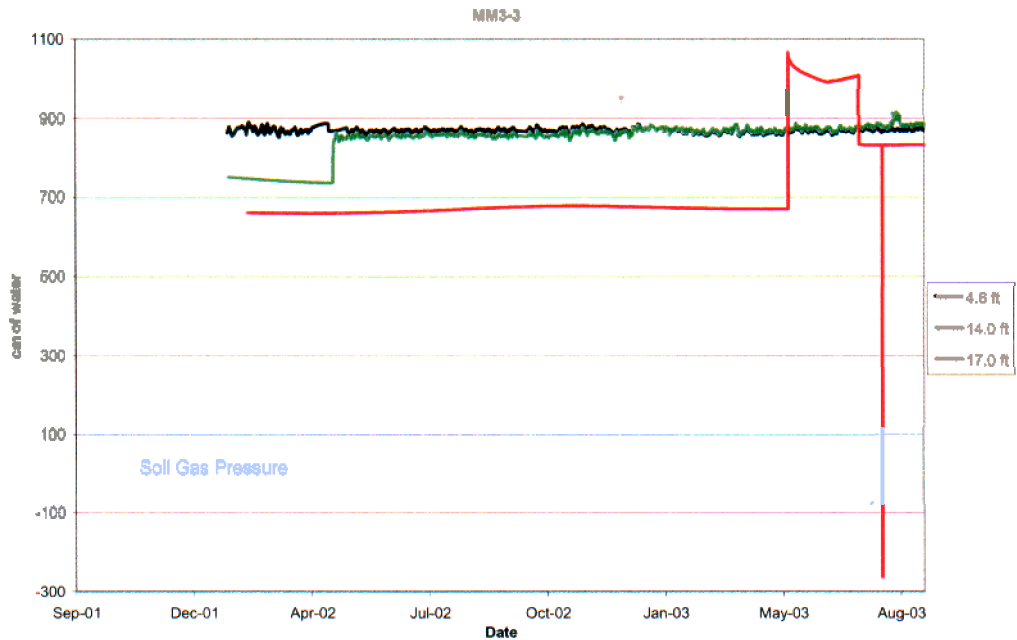
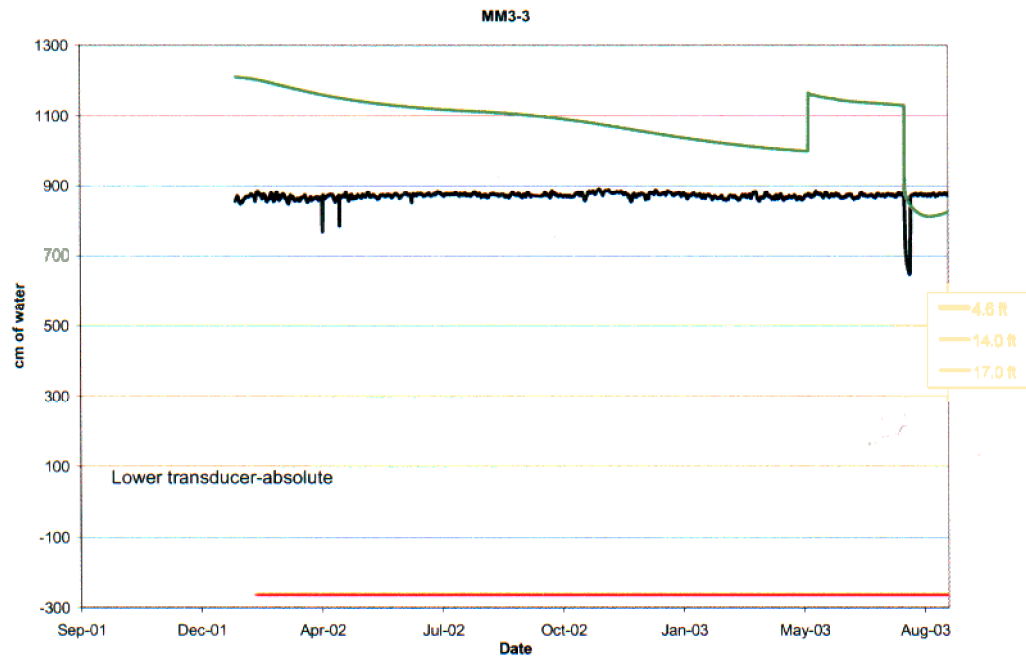
Figure D-18. MM3-3.

T1, 14 ft: Soil gas pressure working, absolute wp transducer possibly coming into range.
 T2, 4.6 ft: Soil gas pressure working, absolute transducer showed signs of working in summer 2003.
 T3, 17 ft: Soil gas pressure range is not consistent, absolute wp transducer—no signal, 273.

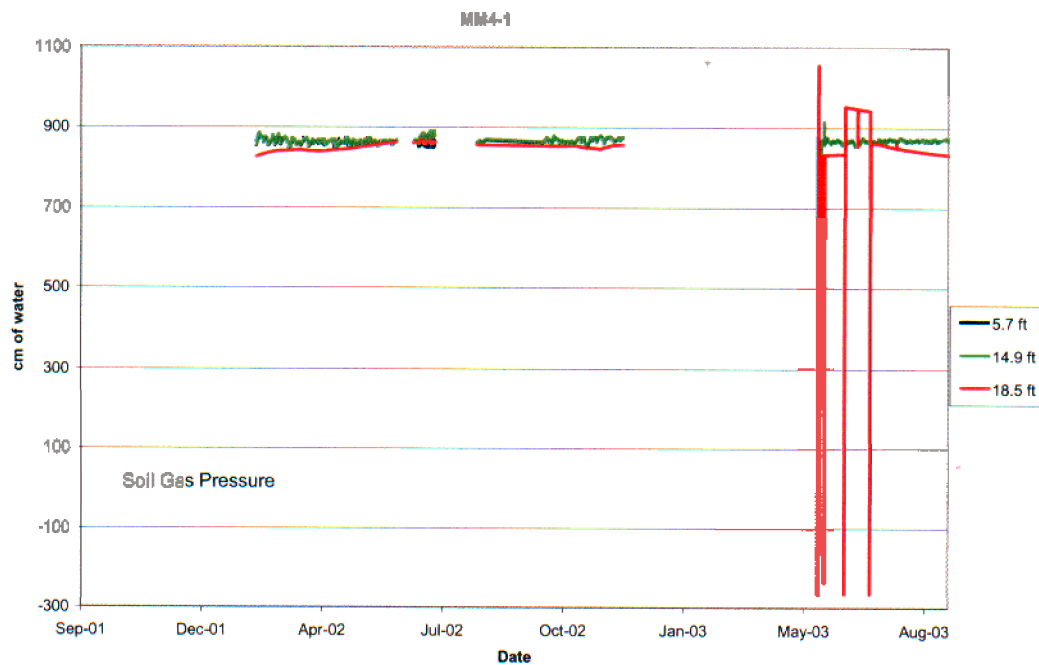
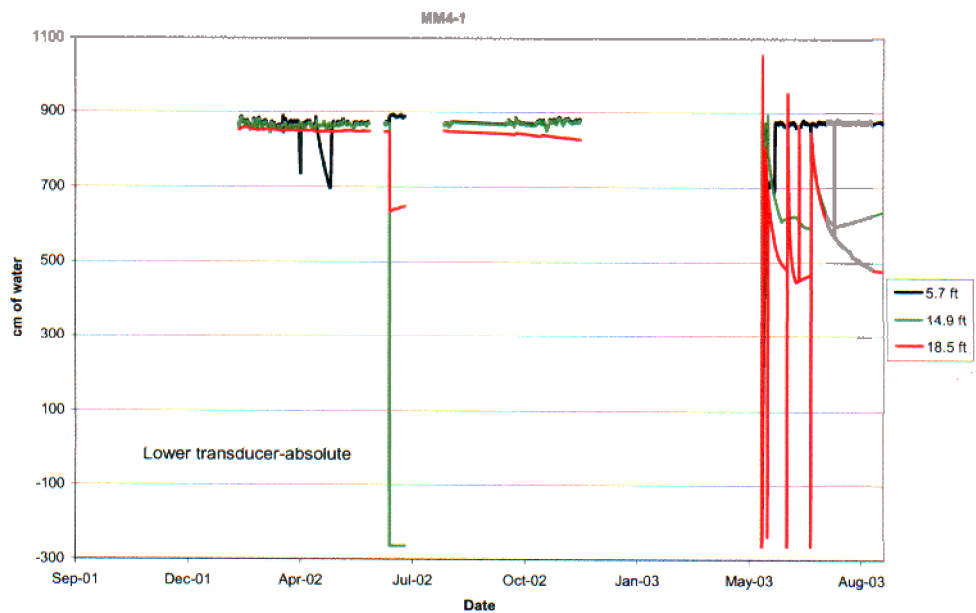
Figure D-19. MM4-1.

T1, 5.7 ft: Soil gas pressure working, absolute wp transducer works sporadically.
T2, 14.9 ft: Soil gas pressure working, absolute wp transducer working sporadically.
T3, 18.5 ft: Soil gas pressure working but hydraulically disconnected from the atmosphere, transducer working sporadically.

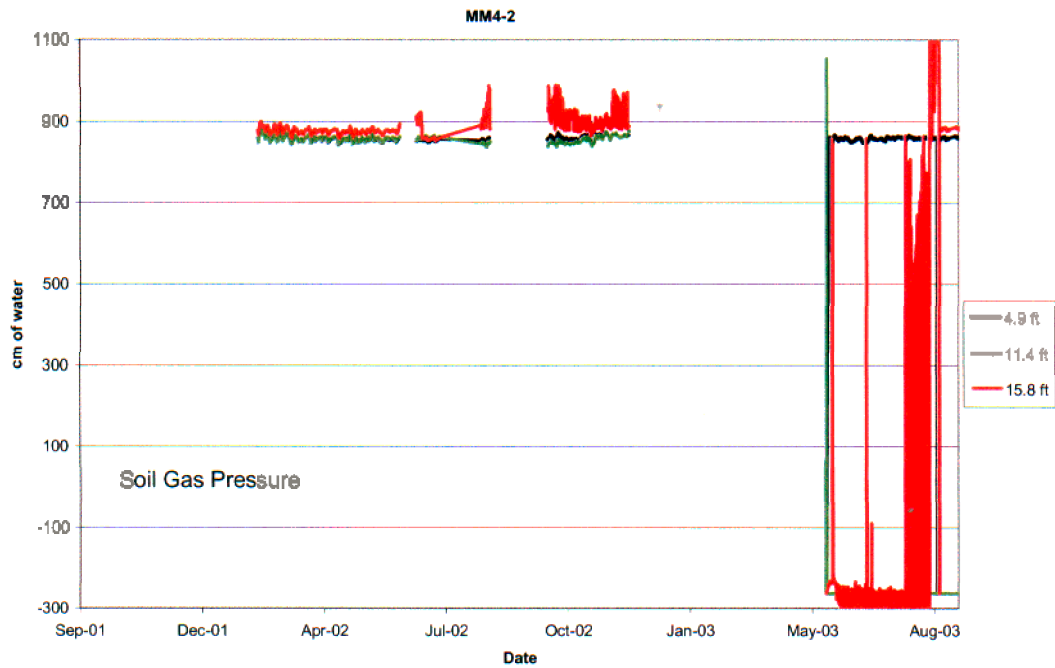
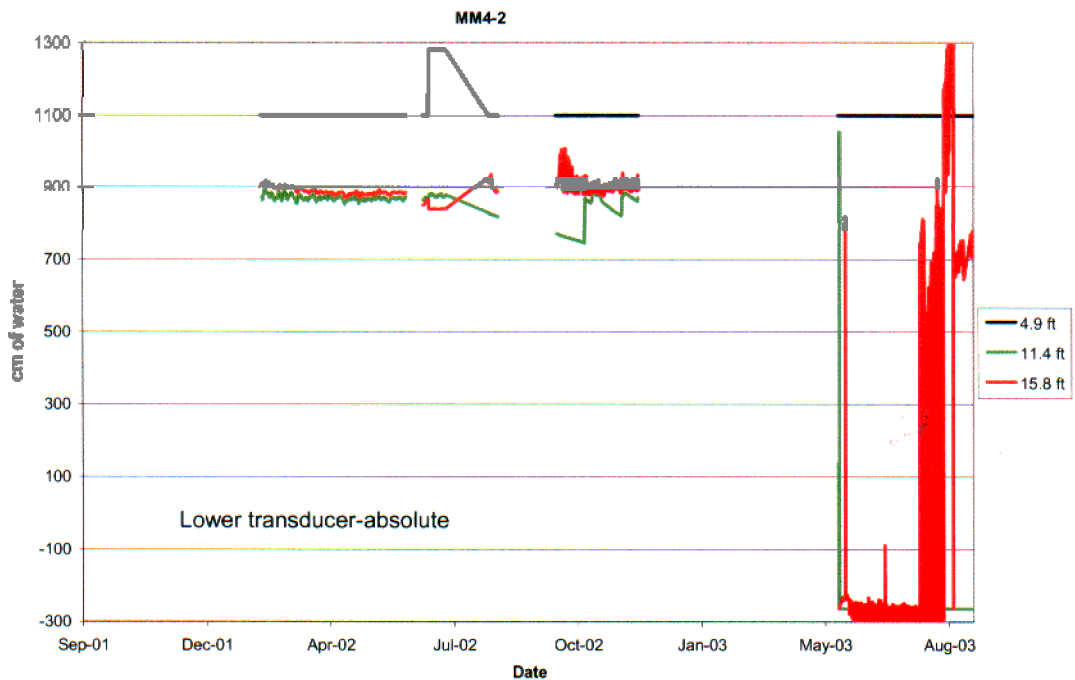
Figure D-20. MM4-2.

T1, 4.9 ft: Soil gas pressure working, absolute wp transducer gives out-of-range readings.
 T2, 11.4 ft: Soil gas pressure no longer working (-273), absolute wp transducer—currently no signal (-273) but has worked in past.
 T3, 15.8 ft: Soil gas pressure working sporadically, absolute wp transducer is not consistent.

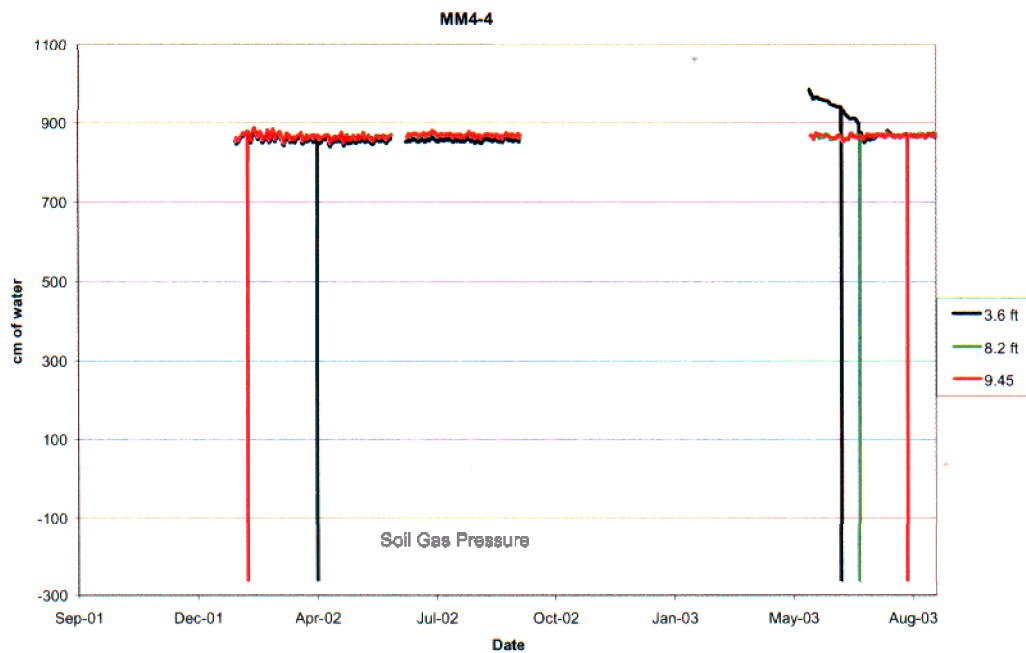
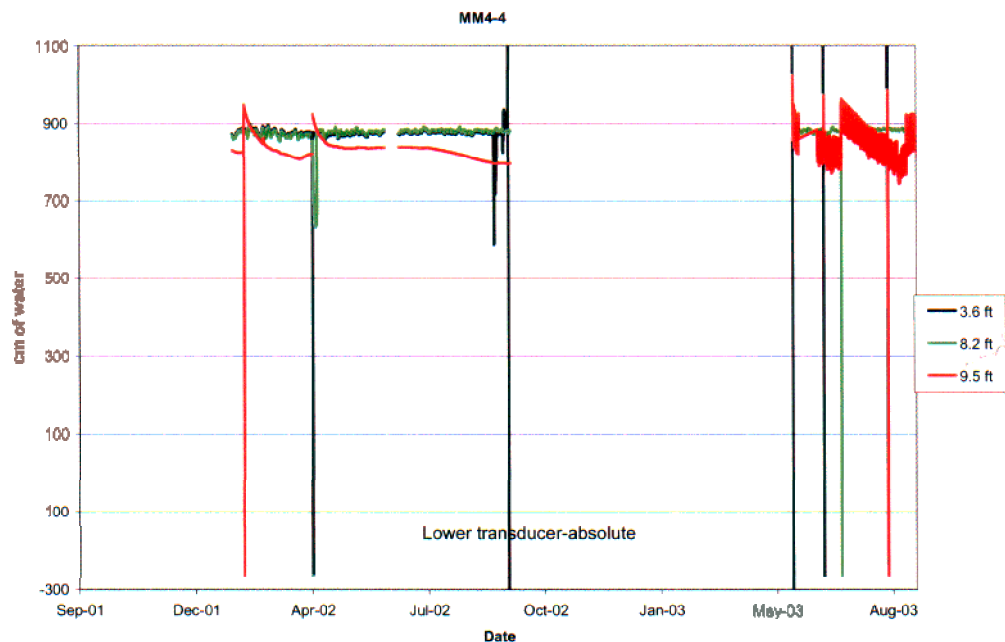
Figure D-21. MM4-4.

T1, 3.6 ft: soil gas pressure working, absolute wp transducer out of range.
 T2, 8.2 ft: soil gas pressure working, absolute wp transducer shows no sign of working.
 T3, 9.5 ft: soil gas pressure working, absolute wp transducer worked sporadically and has electrical problem, may be loose wire.

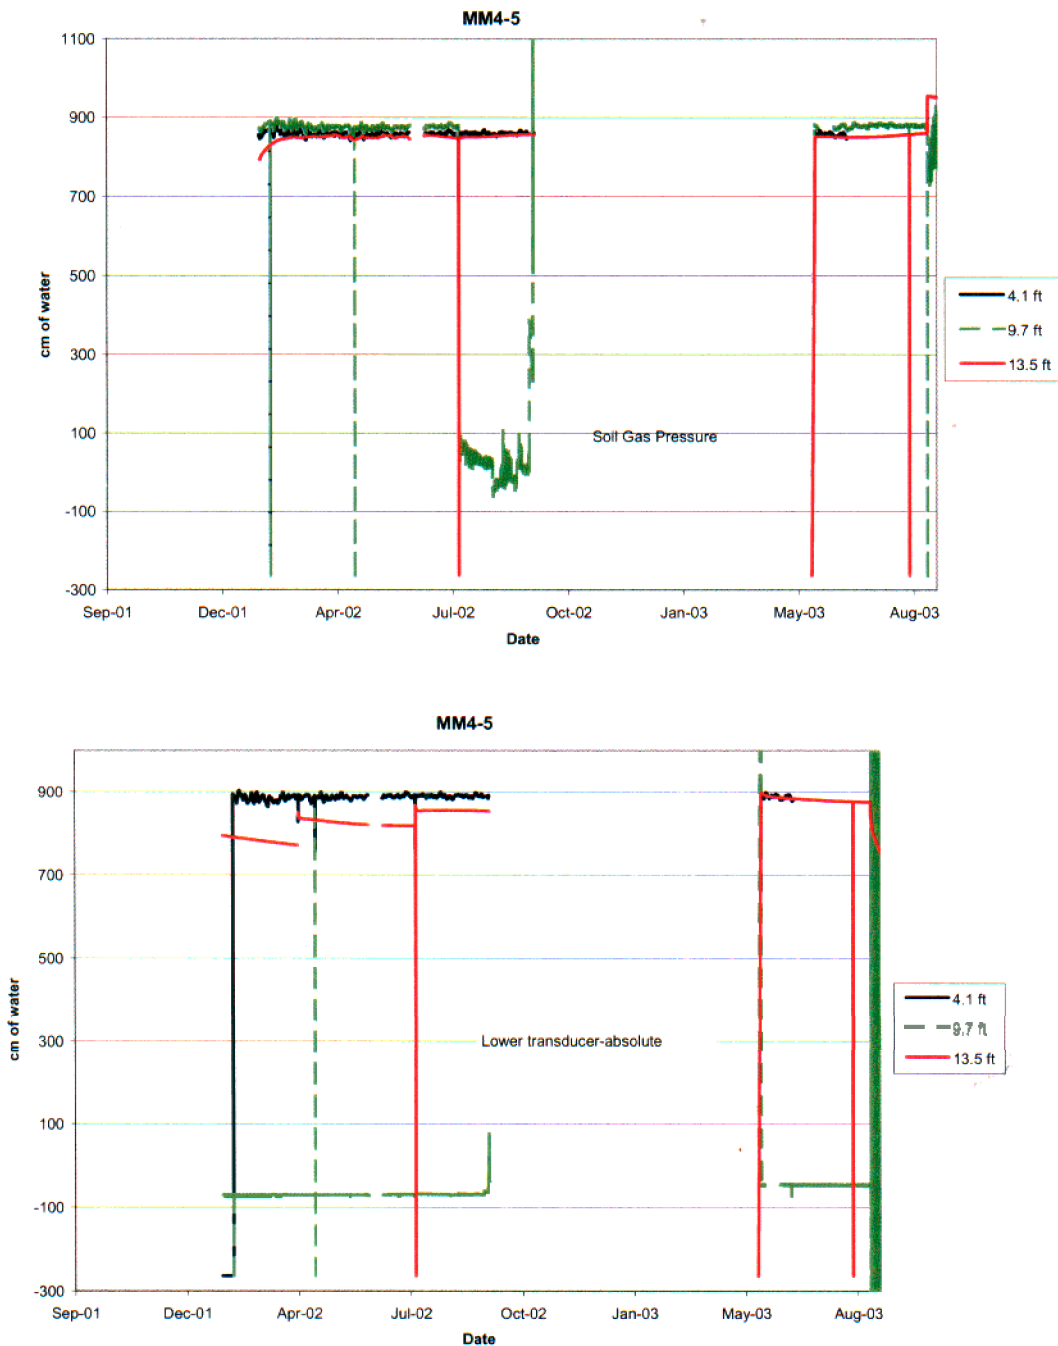
Figure D-22. MM4-5.

T1, 4.1 ft: No soil gas pressure and absolute wp transducer data since June 2003.
 T2, 9.7 ft: Soil gas pressure has worked, absolute wp transducer does not respond.
 T3, 13.5 ft: Soil gas pressure lost calibration, absolute wp transducer appears to be working.

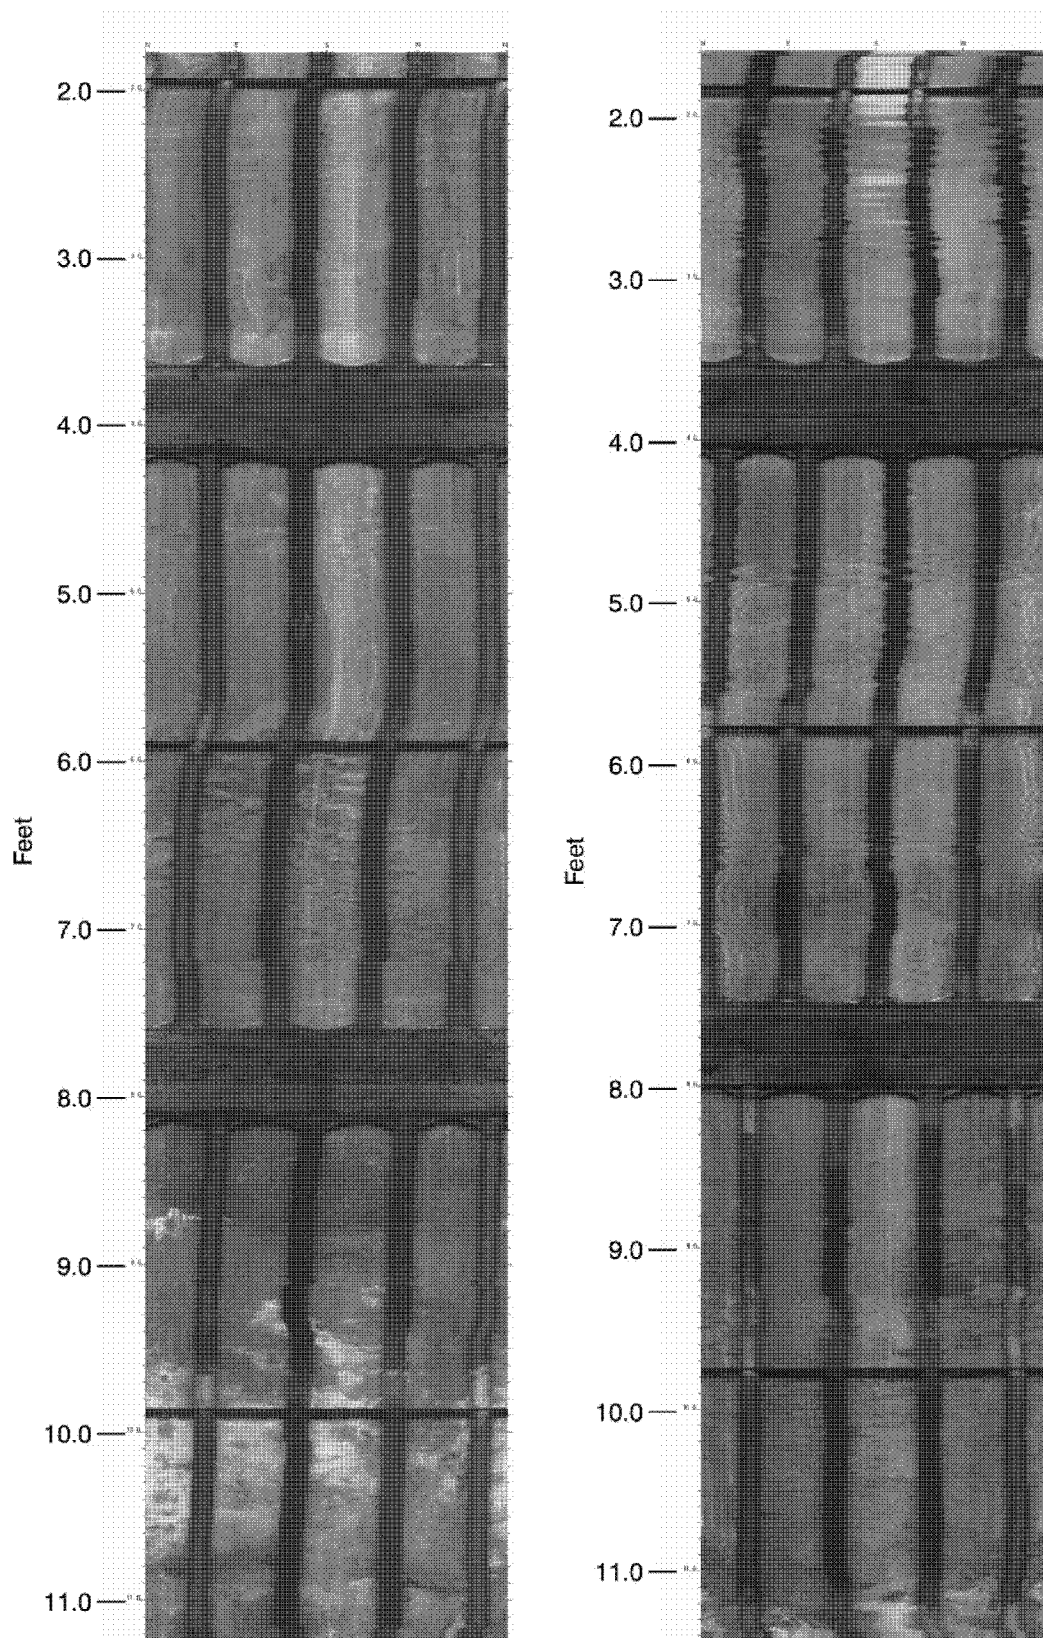
Figure E-1. Visual probe Clusters 743-03 and 741-8.

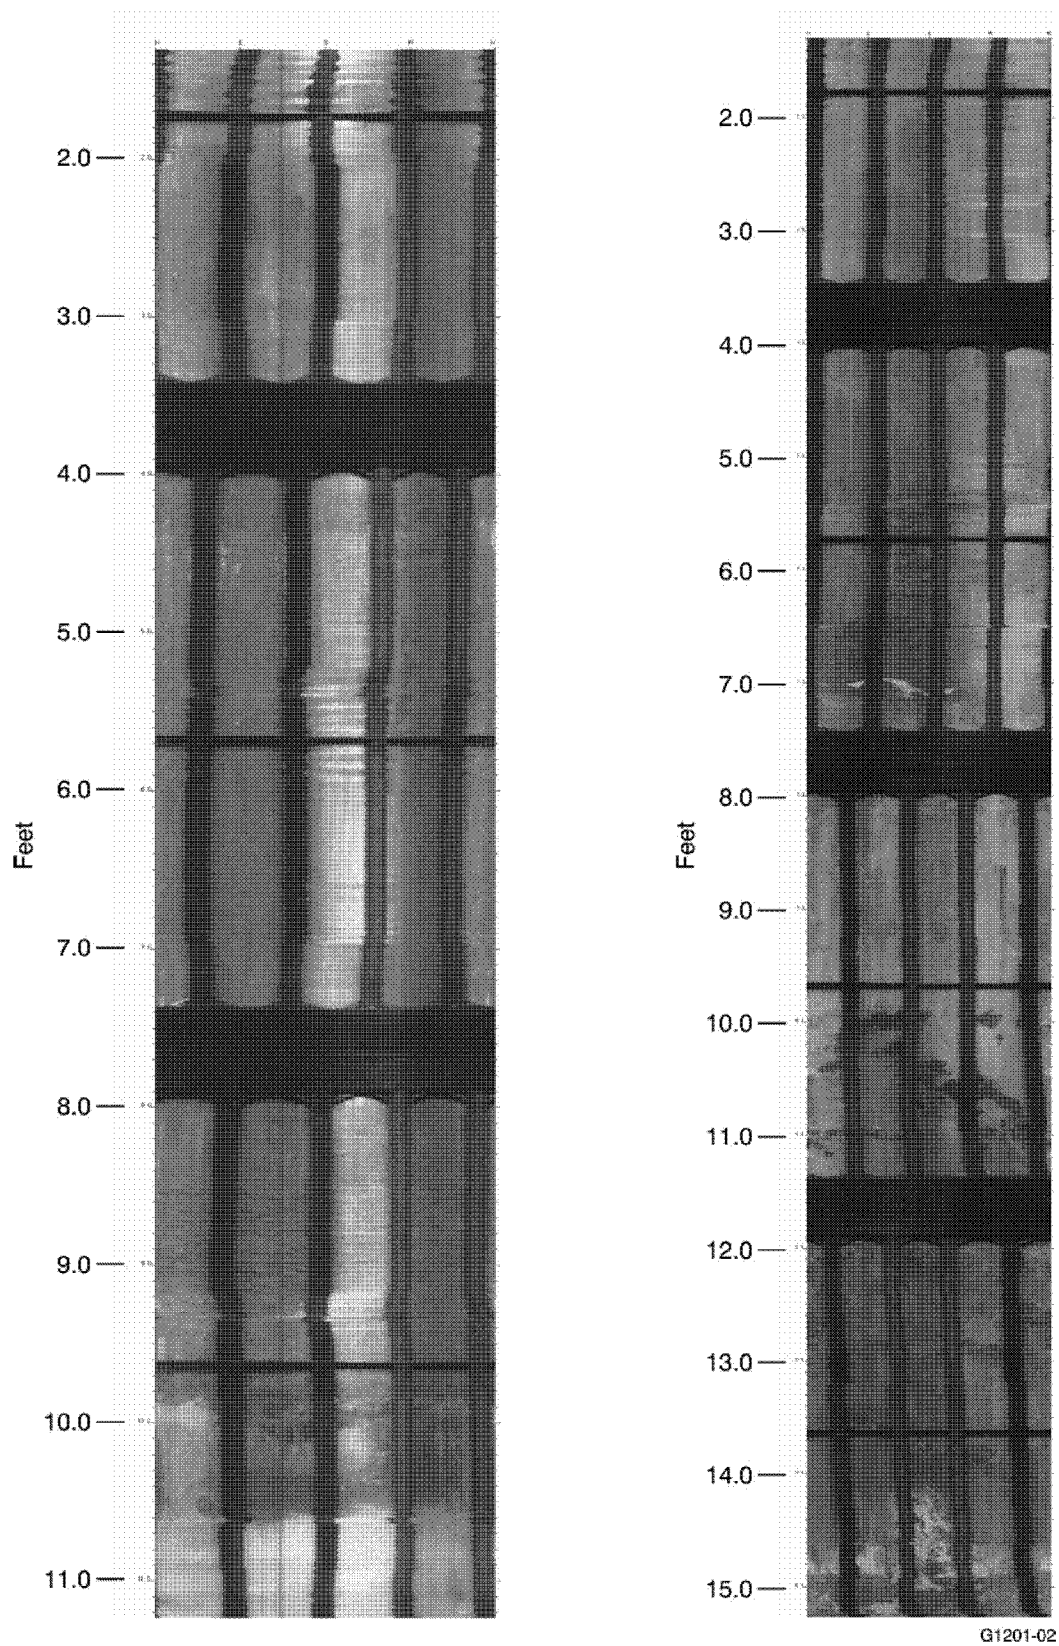
Figure E-2. Visual probe Clusters 743-08 and DU-8.

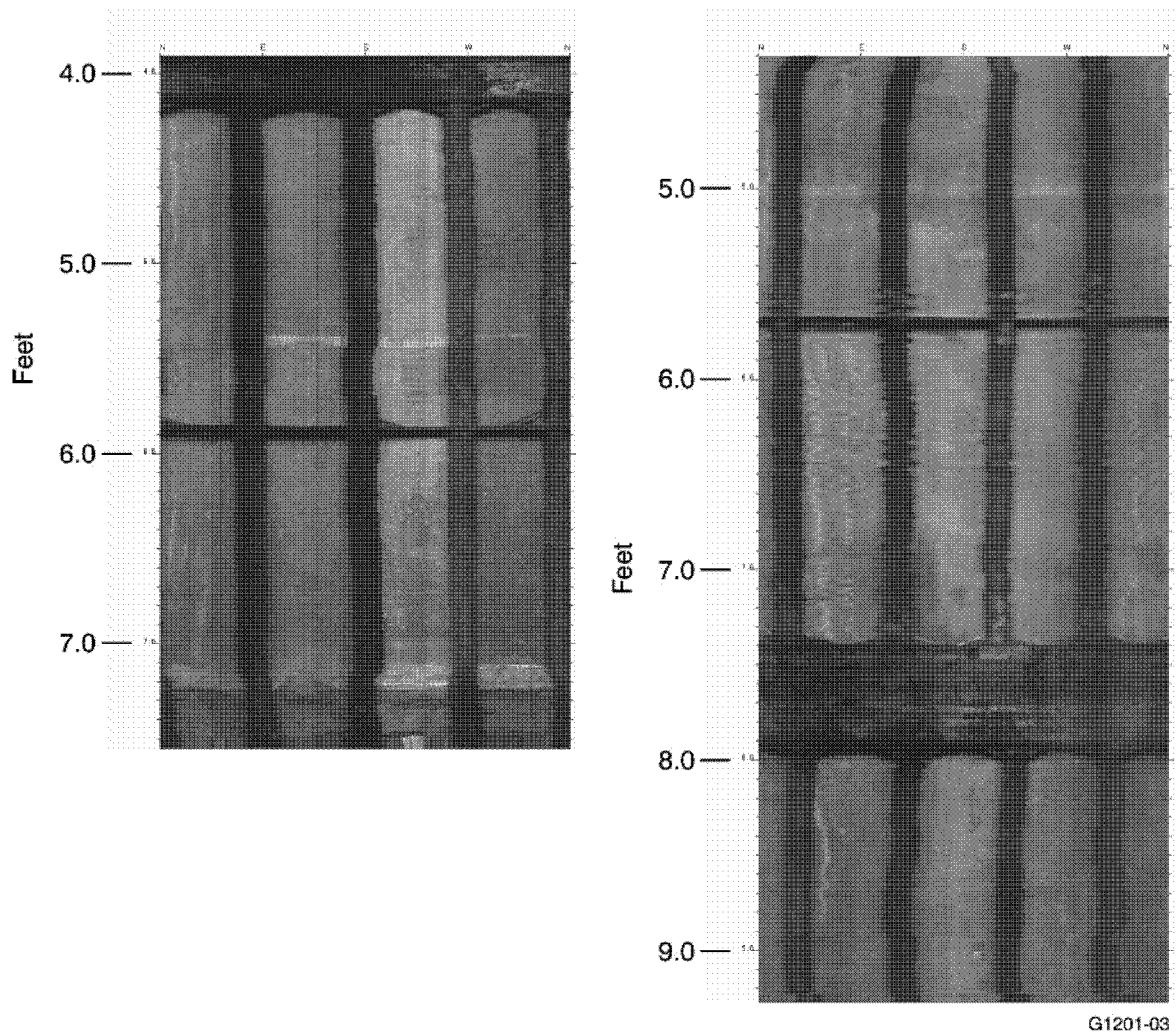
Figure E-3. Visual probe Clusters DU-10 and DU-14.
